The Commonwealth of Massachusetts
Executive Office of Health and Human Services
Department of Public Health
250 Washington Street, Boston, MA 02108-4619

February 2, 2005

As you know, the Massachusetts Department of Public Health (MDPH), Center for Environmental Health's (CEH) Bureau of Environmental Health Assessment (BEHA) conducted an evaluation of indoor air quality at Westwood High School on January 7, 2005. Cory Holmes and Sharon Lee, Environmental Analysts in BEHA's Emergency Response/Indoor Air Quality (ER/IAQ) Program, conducted the assessment. Concerns about musty/mold odors in the social studies wing, suspected to originate from the dirt crawlspace, prompted the request. BEHA staff were accompanied by Heath Petracca, Director of Facilities, Westwood Public Schools (WPS); Pat Coleman, Custodial Supervisor; Karen Poreda, School Nurse, Westwood High School and yourself during the assessment. At the time of the assessment, construction of a new high school adjacent to the existing building was being finalized. School officials reported that the new school was tentatively on schedule for opening in February/March of 2005.

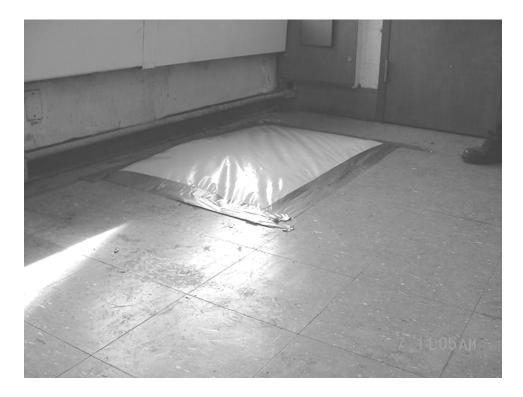
As a result of reoccurring mold odors in the unventilated dirt crawlspace, school department staff attempted to seal utility holes around pipes and floor access panels to prevent odor migration from the crawlspace (Picture 1). BEHA staff observed the polyethylene plastic covering an access panel expanding and contracting from crawlspace air pressure. The assessment occurred on a gusty day, with winds up to 20 mph; therefore, it was determined that the crawlspace was being pressurized from outdoor sources. This was confirmed by the observation of several open windows in the boiler room (Picture 2). The windows were opened intentionally to provide make up air for the boiler. Outside air entering through open windows and/or make-up air vents pressurizes the boiler room and forces air into the crawlspace. The air pressure can then force odors and particulates through any unsealed openings or failing sealants.

Crawlspace Access Panel Sealed with Plastic and Duct Tape; Note "Bulging" of the Plastic, Indicating Pressurization of the Crawlspace

BEHA staff recommended providing local mechanical exhaust ventilation to depressurize the crawlspace. To eliminate and/or reduce any potential pathways of pollutant migration, BEHA staff also recommended further examination and sealing of utility holes, pipes and other breaches between the crawlspace and occupied areas. Mr. Petracca suggested installing local exhaust in the crawlspace access panel in the unoccupied home economics classroom; the exhaust would vent to an adjacent window (Picture 3).

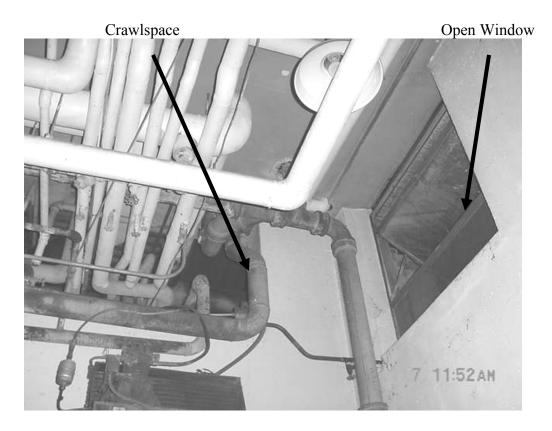
Open Window In Boiler Room and Crawlspace Opening for Pipes

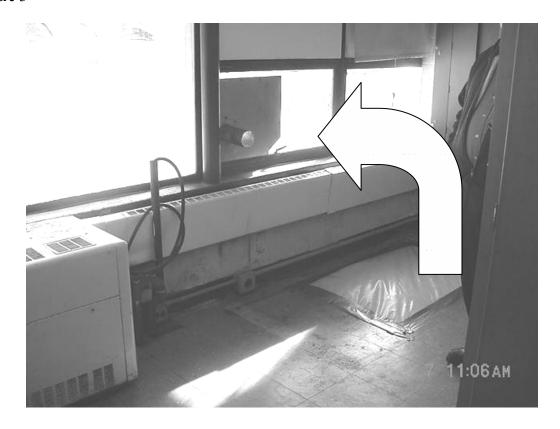
Picture 3

Area Suggested for Crawlspace Local Exhaust Ventilation to the Outside

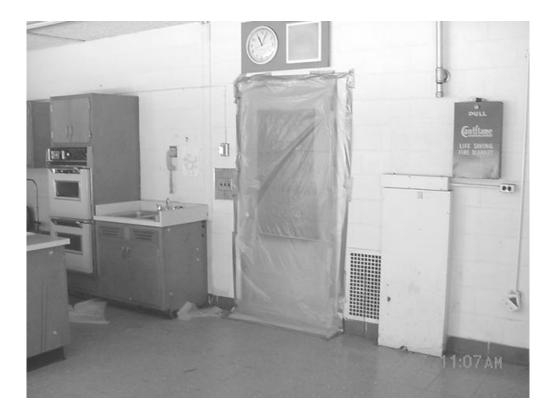
At the time of the BEHA assessment, doors to several unoccupied classrooms that had strong musty odors and/or visible mold growth were sealed using plastic polyethylene sheeting and duct tape from the interior side of the room (Picture 4). BEHA staff recommended sealing these doors on the exterior side as well to provide a duel barrier. Musty odors were also reported in the computer office, where a steam leak had occurred prior to the assessment. BEHA staff observed water-damaged wood paneling around the radiator (Picture 5) and tested it for moisture content. The wood was determined to have an elevated moisture content. BEHA staff recommended that the paneling be removed/replaced. The US Environmental Protection Agency (US EPA) and the American Conference of Governmental Industrial Hygienists (ACGIH) recommends that porous building materials (e.g., wood, carpeting) be dried with fans and heating within 24 to 48 hours of becoming wet (US EPA, 2001; ACGIH, 1989). If porous materials are not dried within this time frame, mold growth may occur. Water-damaged porous materials cannot be adequately cleaned to remove mold growth. The application of a mildewcide to these materials is not recommended.

Sealed Door in Unoccupied Home Economics Room

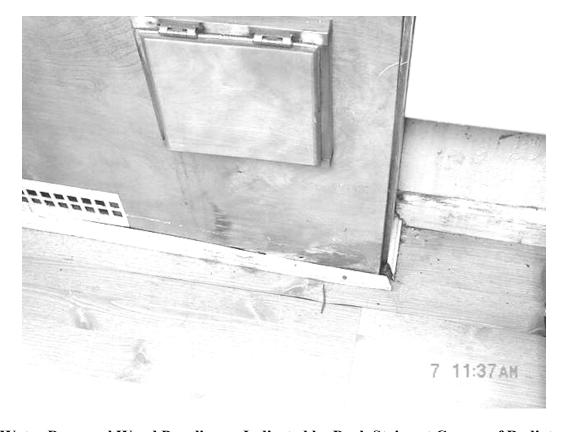
Picture 5

Water Damaged Wood Paneling as Indicated by Dark Stains at Corner of Radiator

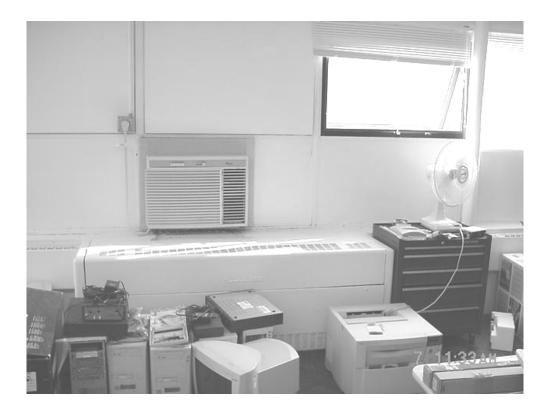
Fresh air to exterior classrooms is supplied by a unit ventilator (univent) system (Picture 6). A univent draws air from outdoors through a fresh air intake located on the exterior wall of the building (Picture 7) and returns air through an air intake located at the base of the unit (Figure 1). Fresh and return air are mixed, filtered, heated and provided to classrooms through an air diffuser located in the top of the unit. Obstructions to airflow, such as papers and books, were seen on univents in classrooms. In order for univents to provide fresh air as designed, they must remain activated and diffusers and intakes must remain free of obstructions. It was reported that several of the univents were deactivated due to excessive heat; however, when the fan is deactivated, it prevents the draw of cool outside air to temper the heated air provided by the univent, which can therefore make the classroom warmer.

Typical Classroom Univent

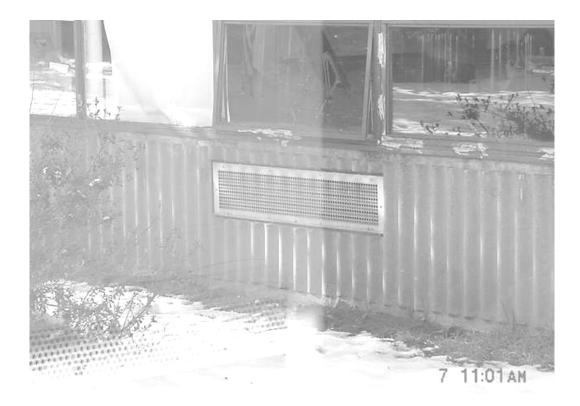
Univent Fresh Air Intake

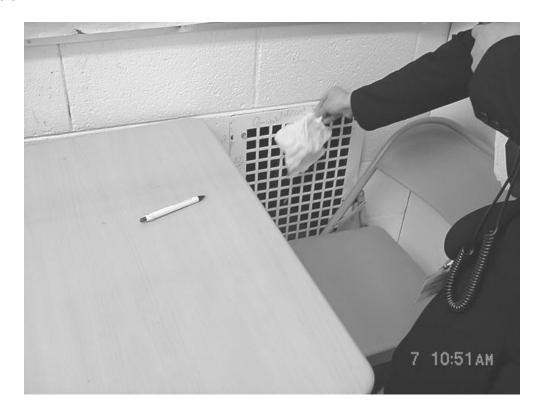
Exhaust ventilation to classrooms is provided by ducted, grated wall vents (Picture 8). No draw of air was detected in several classrooms, which can indicate that exhaust ventilation was turned off, or that rooftop motors were not functioning. As with the univents, to function as designed these vents must be activated.

Typical Classroom Exhaust Vent
